WC Report – DK75 KS Assessment

Customer: Universal Recycling Company

Drill Rig

Assessment of DK75 KS Drill Rig condition.

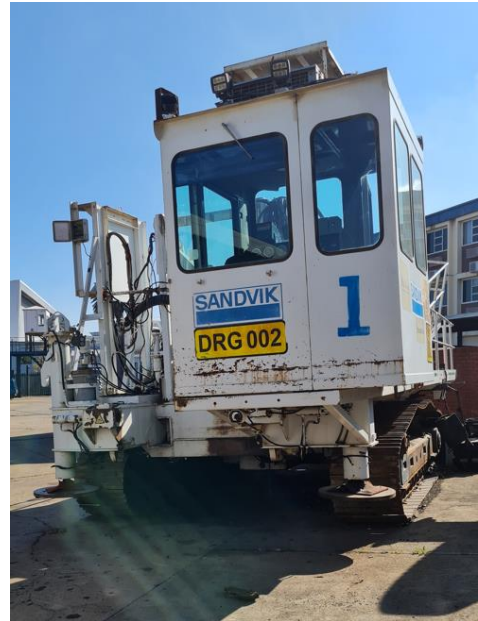
- Rig ID: DRG002
- Hours: 17555
- Model: DK75 KS 2011
- Manufacturer: Sandvik
- Drilling Method: Rotary
- Engine type: CAT 3412
- Compressor: Sullair LLC; Serial: 201403170024
- Drill rig serial number :732977 LP
- Working history: Drill was utilized on a De Beers operation, namely Voorspoed mine. It is a diamond mine, and all drills onsite were part of Sandvik Maintenance contract.
- Tram Hour Reading:1346 hours.

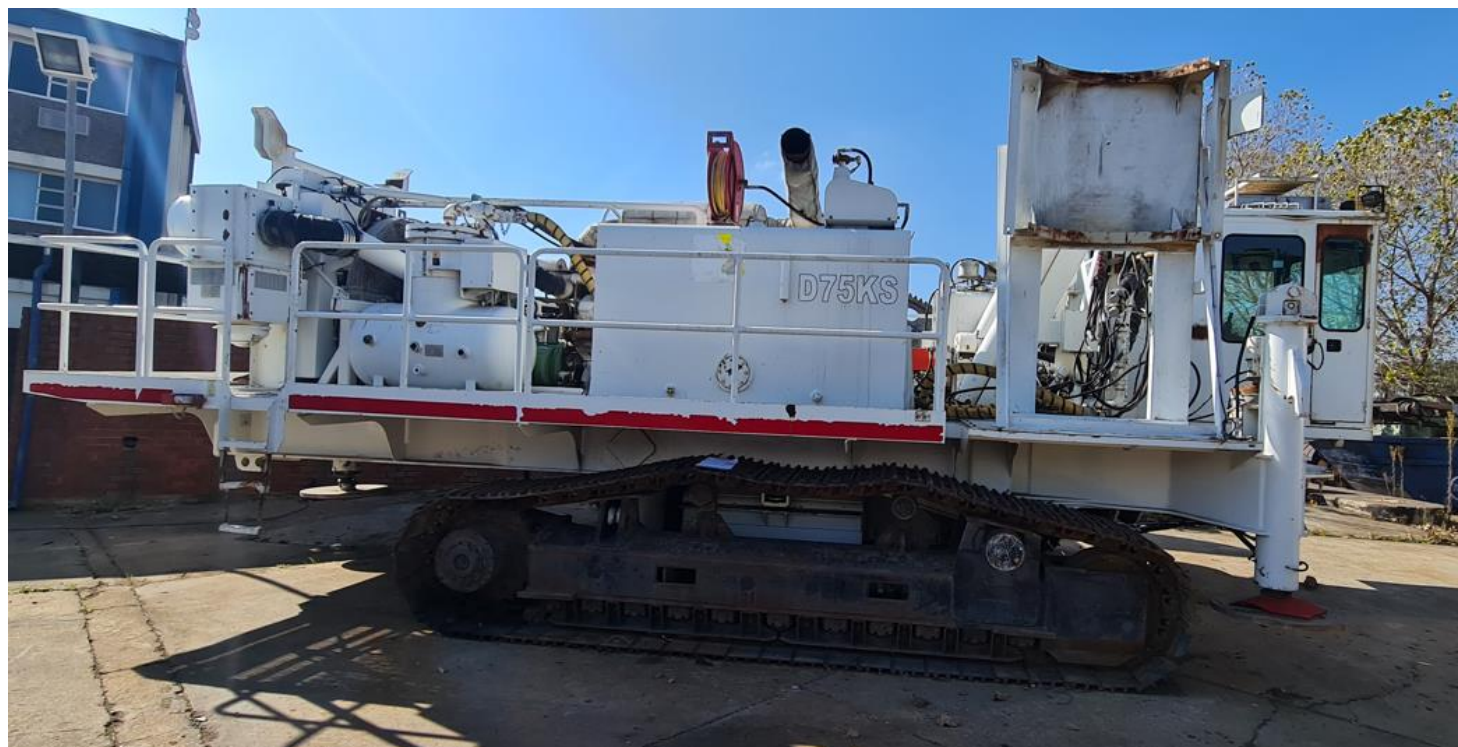
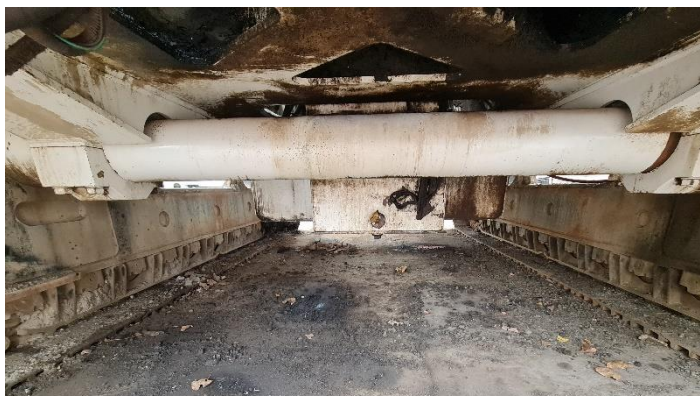
Overall, the DK75 KS is in a good, general working condition. All major components have been changed out recently. The hour reading on the new components is still very low. All the components that have been changed out had been done by the OEM (Sandvik) and the replacement parts changed out is all original sparts.

Structurally, the drill rig is in an extremely good condition. There are no signs of any cracks on either the undercarriage, the frame, cabin and mast.

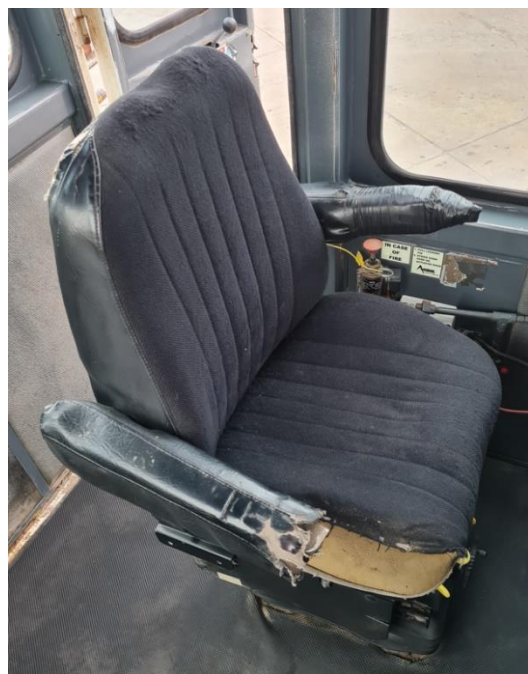
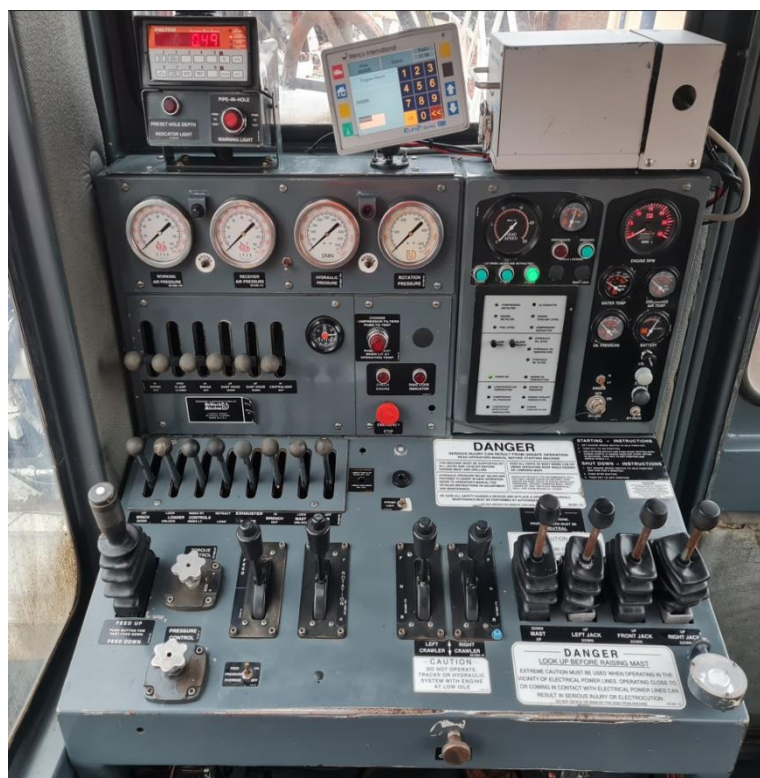
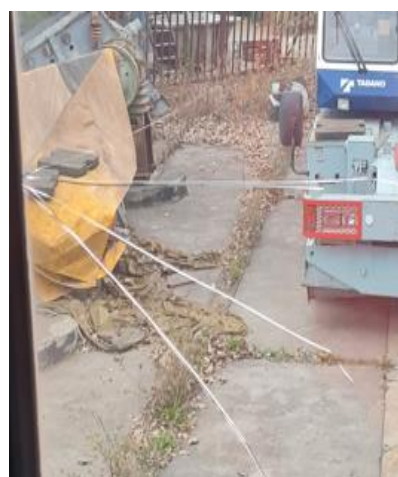
Inside Operator's Cabin:

- Both doors are in good, functional condition, however the seals on both doors need to be replaced.
- Windows: 4 x windows cracked- due for replacement.
- No wipers on the rig.
- Aircon gauges and switches are all in good, functioning order. However, the RPM Gauge glass needs to be replaced.
- Seat: Needs to be re-upholstered, as fabric and sponge lining is in poor condition, as well as fabric on arm rests.

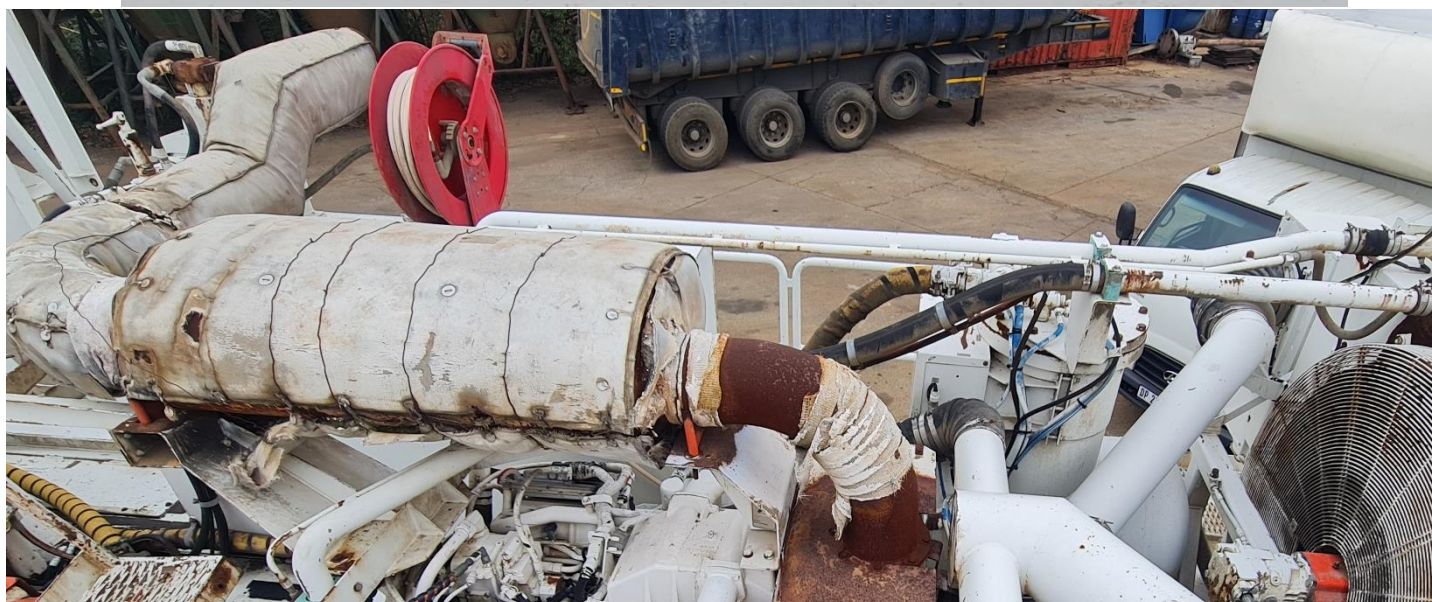
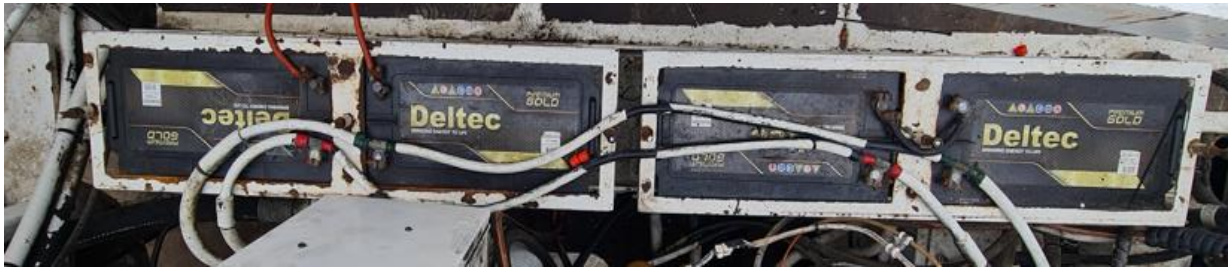
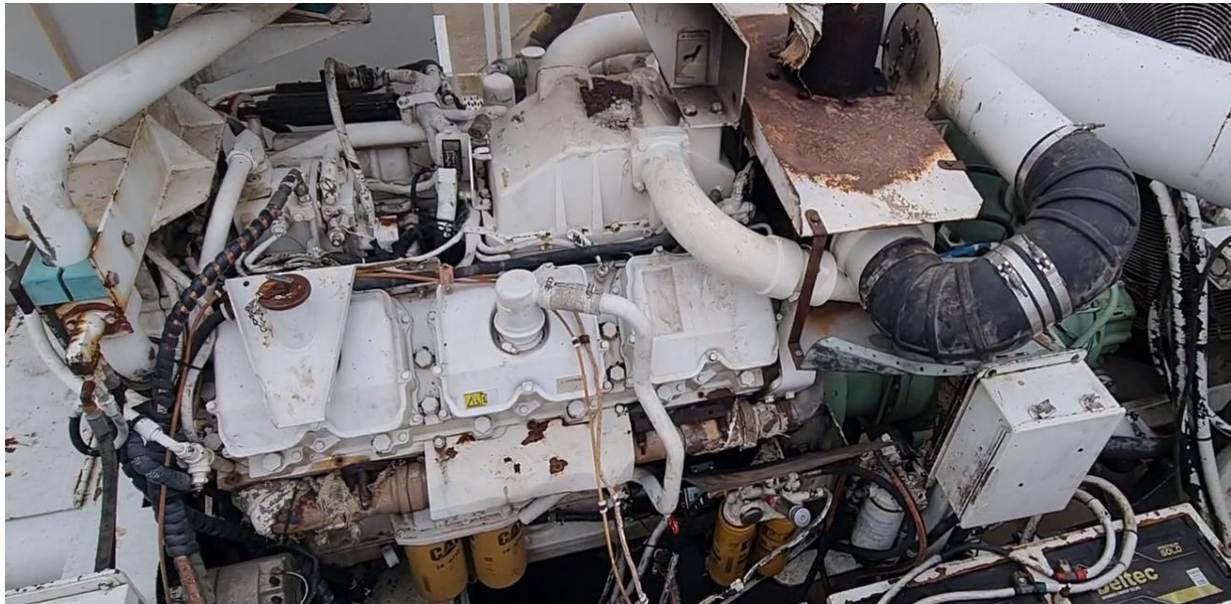
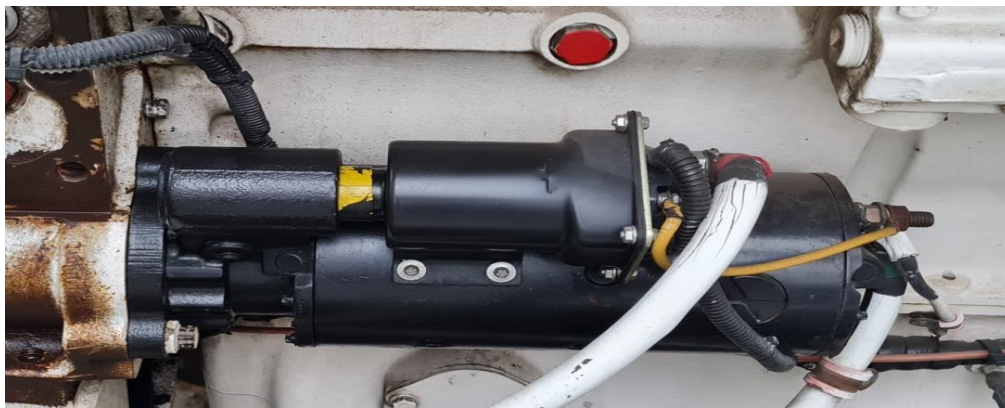
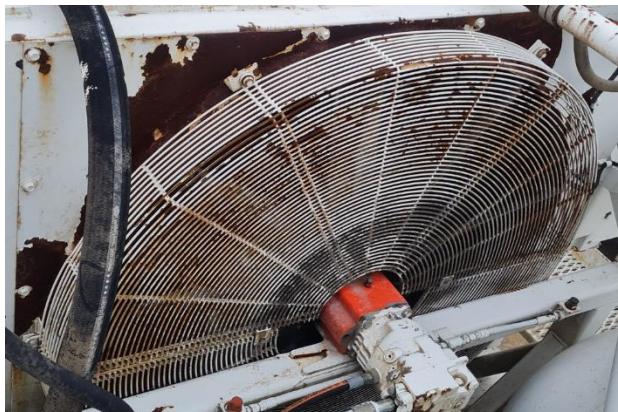
Engine: Serial number: BDT04341

- The CAT3412 engine is in a good working condition. Engine Rebuild had been done by Barloworld.
- Engine start-up is smooth and no irregular smoking occurs.
- The engine is fitted with 2 x new starters.
- The engine is fitted with 4 x new batteries.
- Fluid levels are all appropriate.
- The engine is due for service, as the drill rig has been standing for quite a while (approx. 3 years)
- Heat shield-covers on engine are worn; replacement recommended.

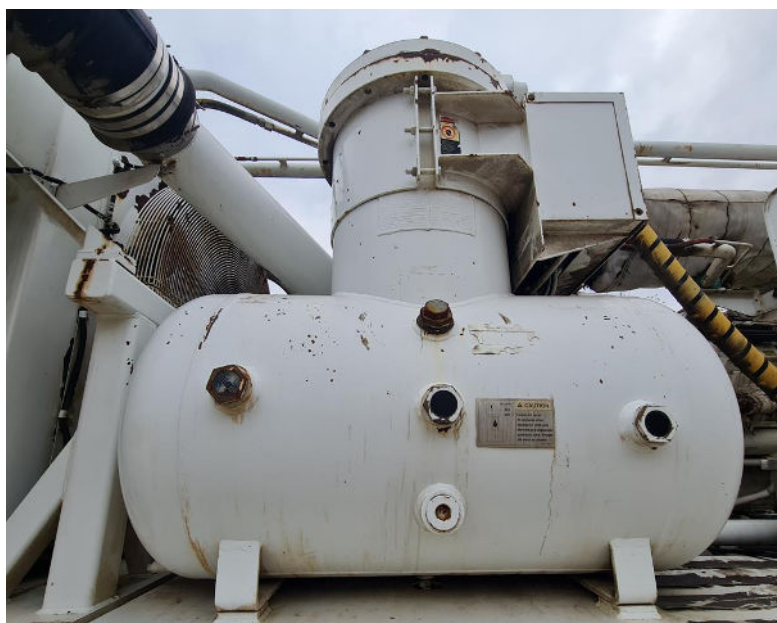
Compressor:

- The compressor has only run 3 878 hours. A new compressor and Air-End had been fitted.
- Compressor performance is good; no signs of overheating occurred.

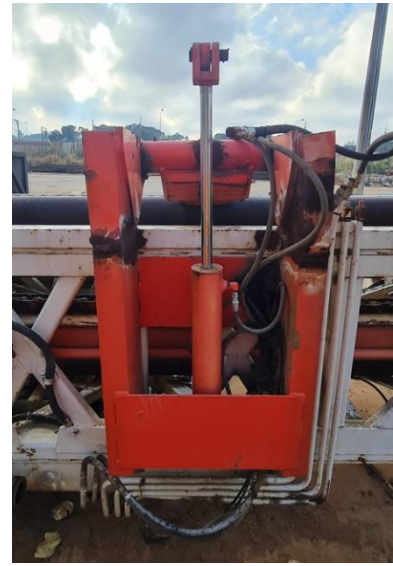
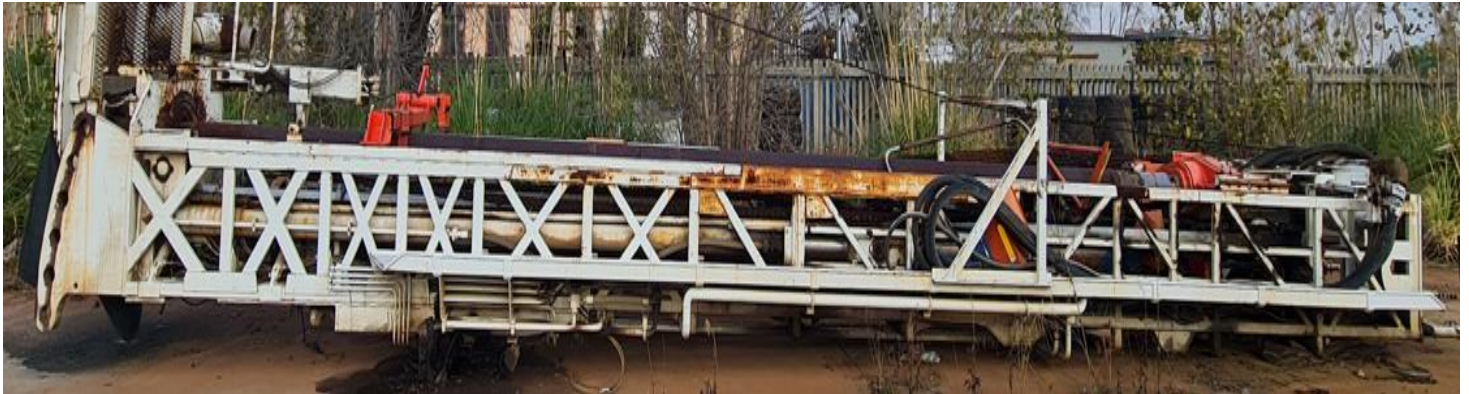
Mast:

- The mast pins and bushes are new.
- Rotary head- Only has 1544,7 hours on and is in a very good condition.
- The mast structure condition is very good and well looked after.
- There a 2 new rotation motors on the rig.
- The mast slides appear to be in a very good condition, no deep marks or scoring visible.
- The mast chains are in a good condition and properly tensioned.
- The rod handlers are working and in good condition.

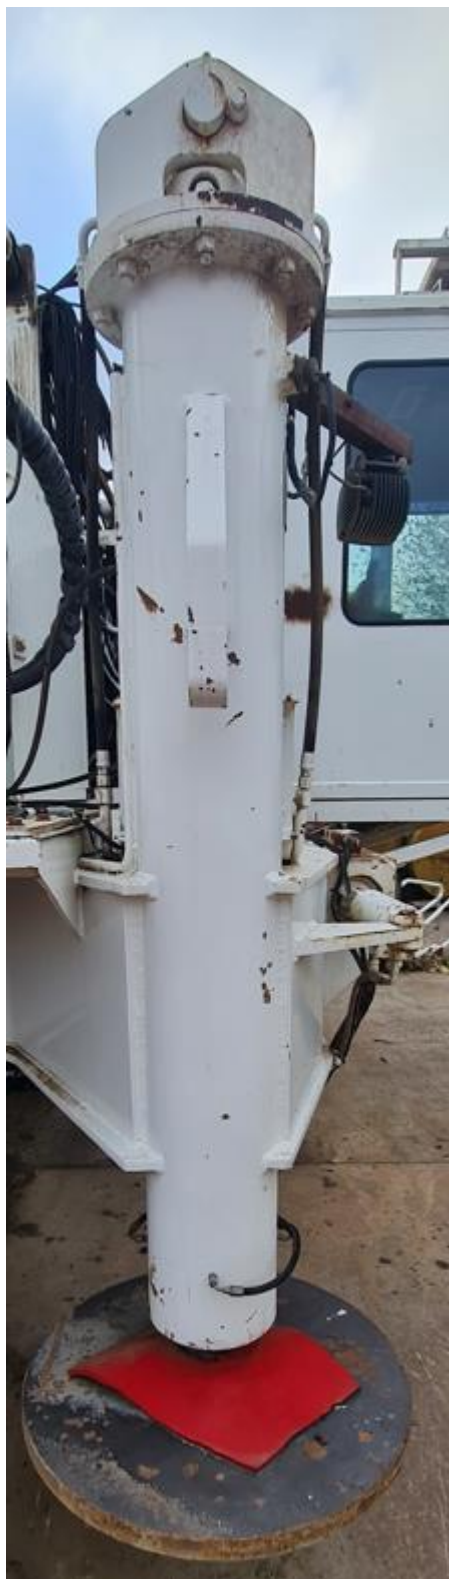
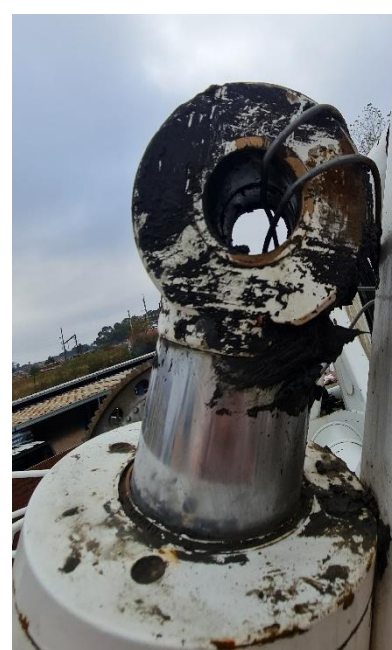
Hydraulic Components:

- All the hydraulic cylinders are in good, working order.
- The mast lift cylinders were recently reconditioning and are basically as new.
- There is no evidence of any scoring on cylinder shafts; all cylinder seals are intact.
- There is a small leak on the Hydraulic valve bank, suspected seal replacement necessary.
- All 3 x Outriggers are functional.
- All hydraulic motors are in good working order.
- Some hydraulic hoses leading to the mast is due for replacement.

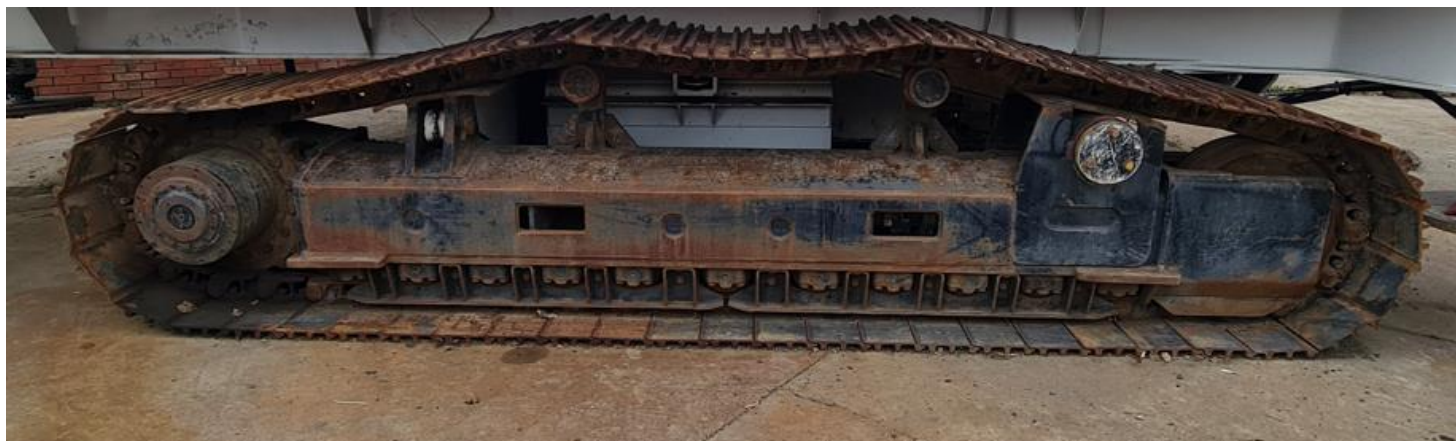
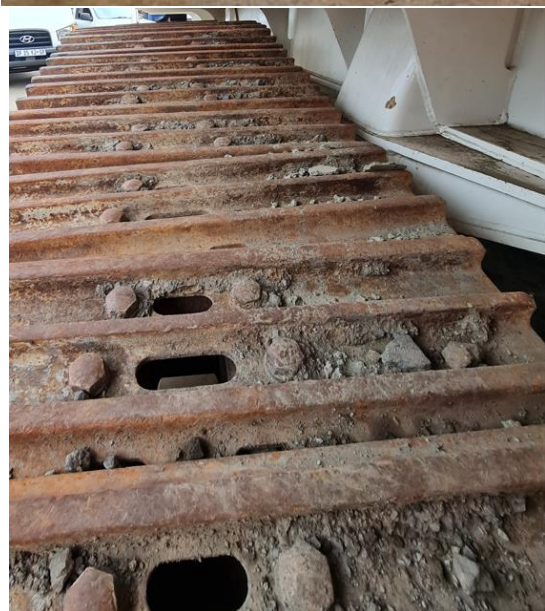
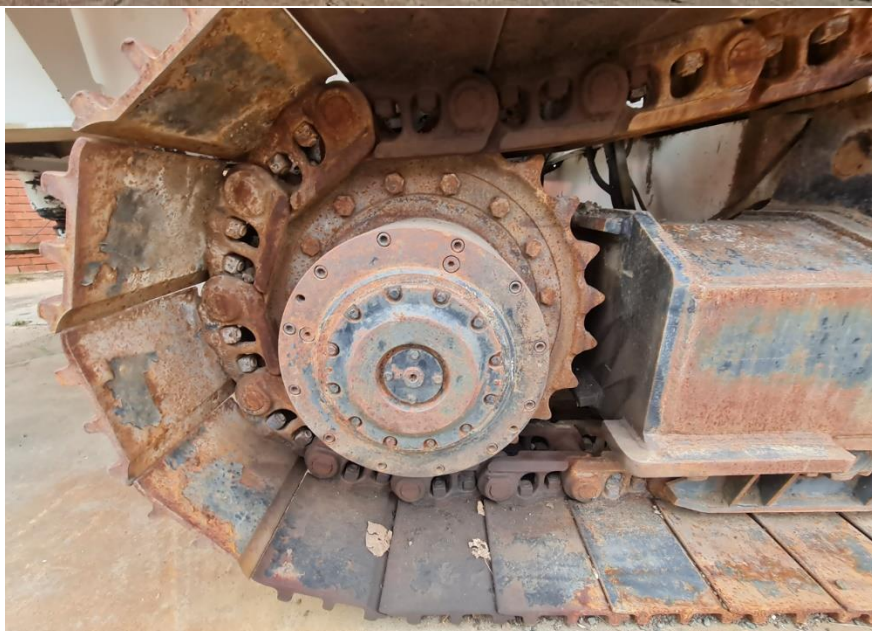
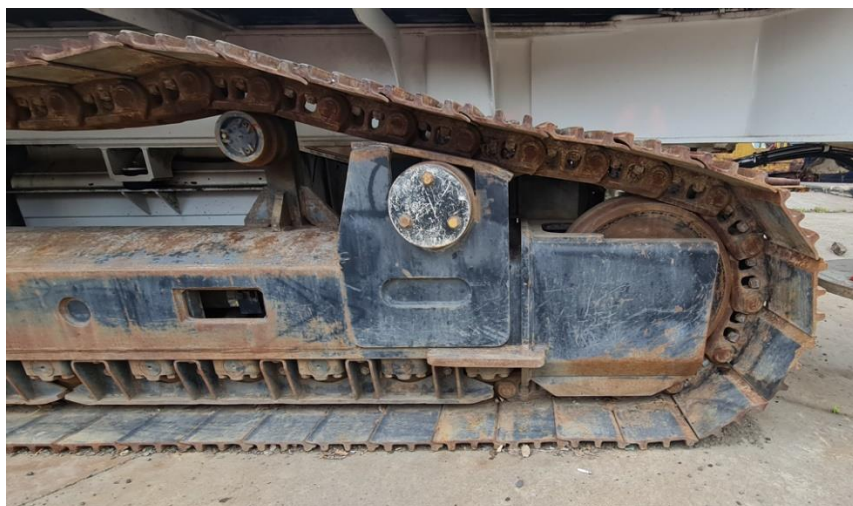
- Undercarriage is in a very good condition, with CAT sprockets and roller from ITR.
- The Shoes, bushes, Idlers, and rollers are in a very good condition.
- Track repairs were done by Barloworld.
